TEST REPORT

REPORT NO. : 25201800974

NAME OF SAMPLE: SHELL MOSAIC

APPLICANT: FOSHAN GLOBAL BRIDGE
BUILDING MATERIALS CO., LTD.

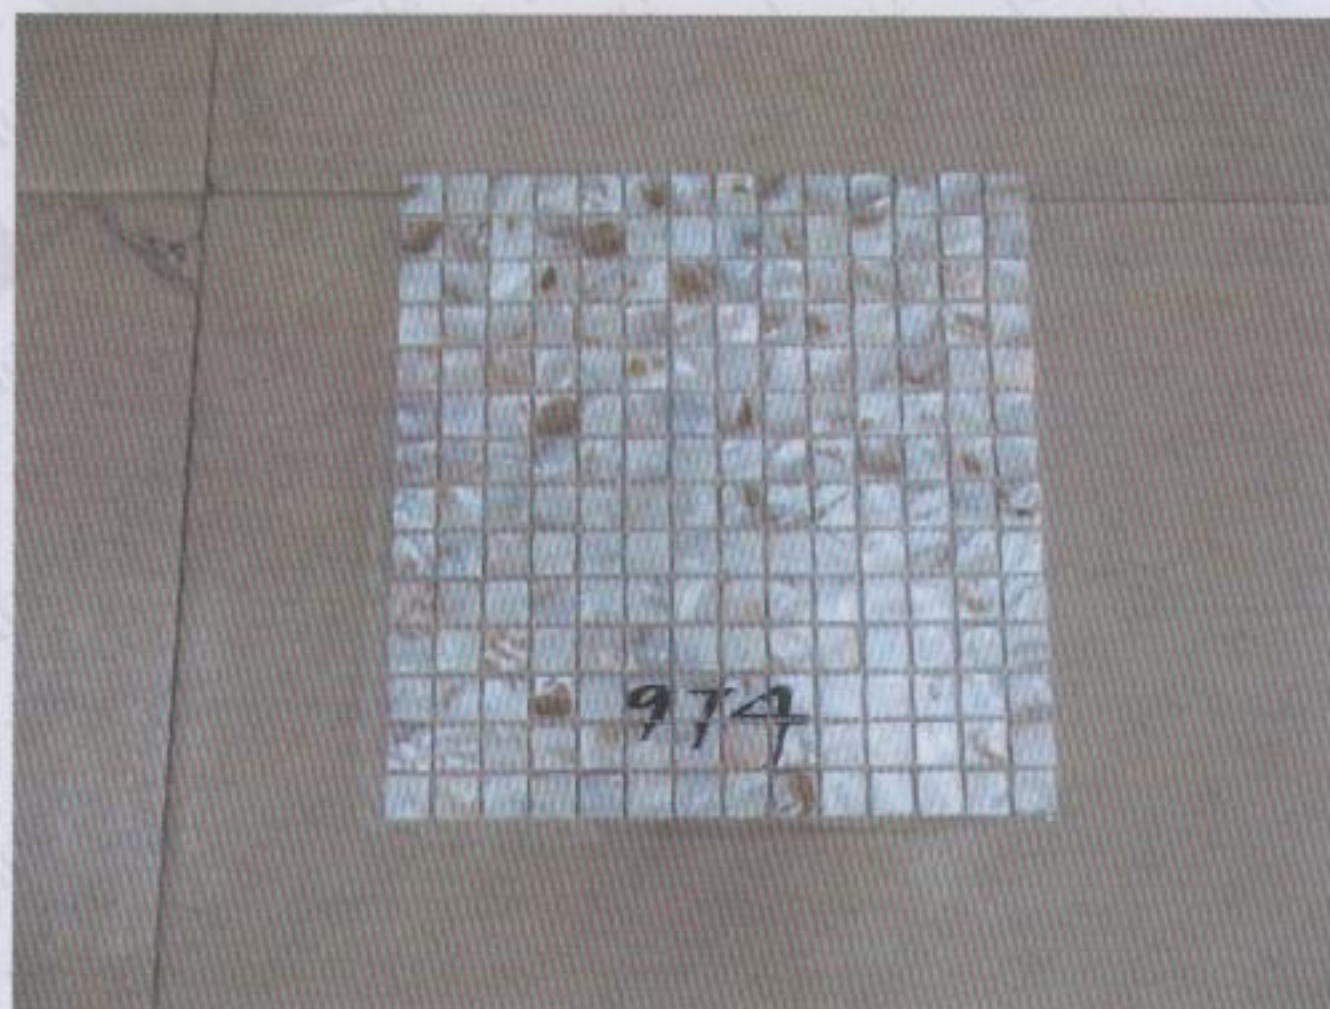
Photo of Samples

Name of sample	SHELL MOSAIC	Nominal size (N)	30.5cm×30.5cm
Nature of the surface	Unglazed (UGL)	Work size (S _w)	305mm×305mm×2mm
Group	B I a	Description of Samples	The samples are sound, intact and fit for test.
Mark of samples	PJA51	Quantity of samples	30 Pieces
Applicant	FOSHAN GLOBAL BRIDGE BUILDING MATERIALS CO., LTD.	Address of applicant	NO.6 BUILDING,HUIZHAN 2ND RING ROAD,HUAXIA CERAMIC EXPOSITION CITY,NANZHUANG TOWN,CHANCHENG DISTRICT,FOSHAN CITY, GUANGDONG,CHINA.
Telephone of applicant	86-757-88023705	Fax of Applicant	86-757-85396111
Source of Samples	Samples selected by applicant	Received on	28/02/2018
Test Standard	ISO 13006:2012 <i>Ceramic tiles – Definitions, classification, characteristics and marking</i> Annex G Dry-pressed ceramic tiles with low water absorption $E_b \leq 0,5 \%$ Group B I a		
Conclusion of Test	The results conform to the requirement of Annex G of standard ISO 13006:2012 with respect to the test items.
